TWA Flight 800 Missile Impact Analysis

by
Richard Bott
Survivability Division
Systems Engineering Department

DECEMBER 1997

NAWCWPNS TM 8126

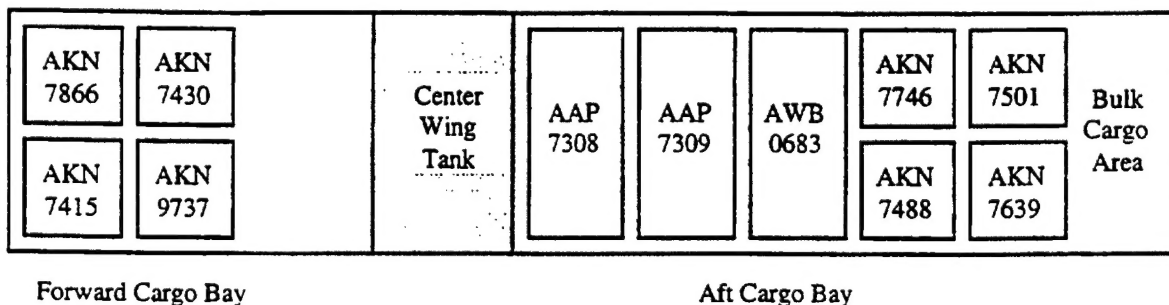
FIGURE 1. Cargo Container Locations on TWA Flight 800.

Four baggage containers were located in the forward cargo compartment of TWA Flight 800. A diagram of all container locations is shown in Figure 1. The two containers on the left side of the aircraft, AKN7415 and AKN9737, were recovered in the red debris field and were not severely damaged. Both containers have virtually all sides intact, and the damage is consistent with water impact.

The two containers on the right side of the forward cargo hold, AKN7866 and AKN7430, were recovered in the yellow debris field. These containers are more severely damaged, but the majority have been recovered and reconstructed. The damage also appears to be attributable to water impact.

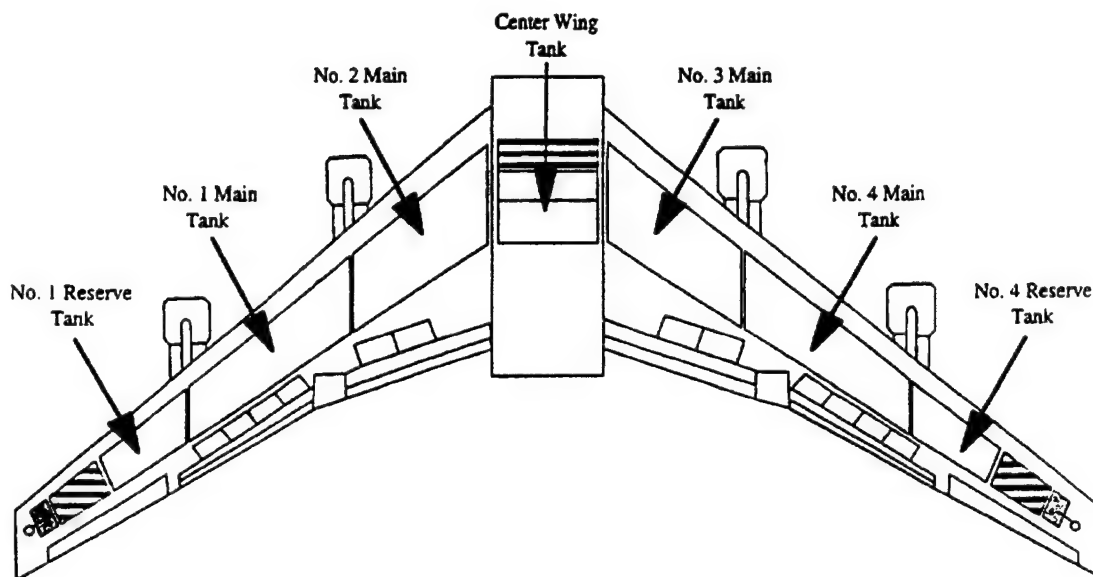
FIGURE 2. Boeing 747-100 Fuel Tank Arrangement.

The thickest part of the wing fuel tanks are at the fuselage where the number 2 and number 3 main tanks butt up against the center wing tank. A schematic of the 747 wing fuel

tanks is shown in Figure 2. The kinetic energy of the missile body and the explosive energy of the detonating warhead would create a significant hydrodynamic ram event that could cause severe damage to one or more of the following structures even though the possibility exists that warhead fragmentation damage would not occur:

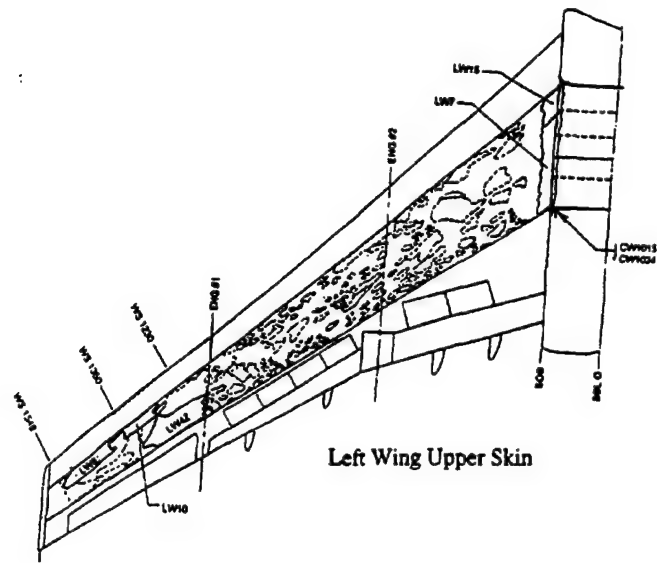
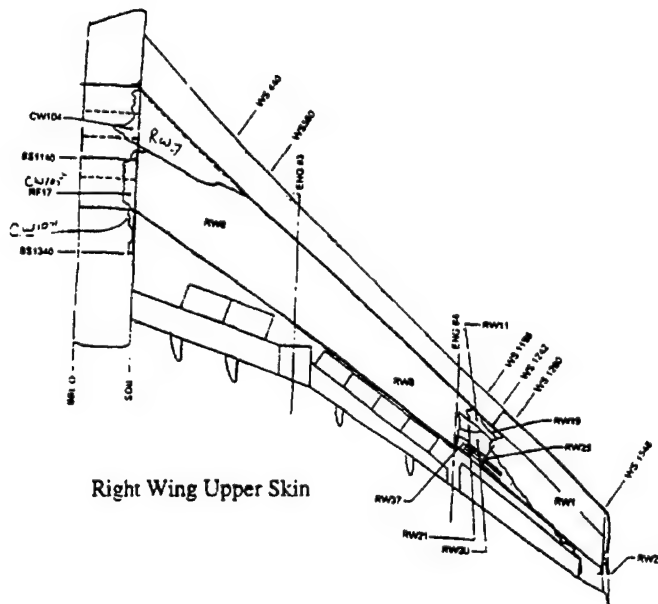
FIGURE 3. TWA Flight 800 Upper Wing Skin Damage.

Detailed examinations of the TWA Flight 800 wing fuel tanks were conducted. The left upper wing skin, the left side-of-body rib, and the left leading-edge spar exhibit different and more severe damage from their right wing counterparts. Figures 3, 4, and 5 show comparisons of the damage to the upper wing skins, side-of-body ribs, and inboard leading-edge spars, respectively. Close inspections of the wreckage in these areas revealed no evidence of penetrations by foreign objects and no high-velocity fragment damage consistent with a missile impact. NTSB and FBI documentation support these findings (References 3 and 4).

Some unexplained damage characteristics on these structures have puzzled investigators, for example, the severe shattering of the left wing upper skin. While the damage mechanisms involved may not be completely understood, the recovery and reconstruction of TWA Flight 800 is the most comprehensive undertaking of its type ever made. This wing damage may be typical for severe water impacts but has gone unnoticed in previous mishaps due to the lack of recovery and reconstruction of debris. Further, the left and right wings of TWA Flight 800 impacted the water in different attitudes, as evidenced by the damage to the engines, which may explain the disparity in damage between the two structures. These damage characteristics are not deemed characteristic of a missile impact. but without validating test data this conclusion cannot be made with 100% certainty.

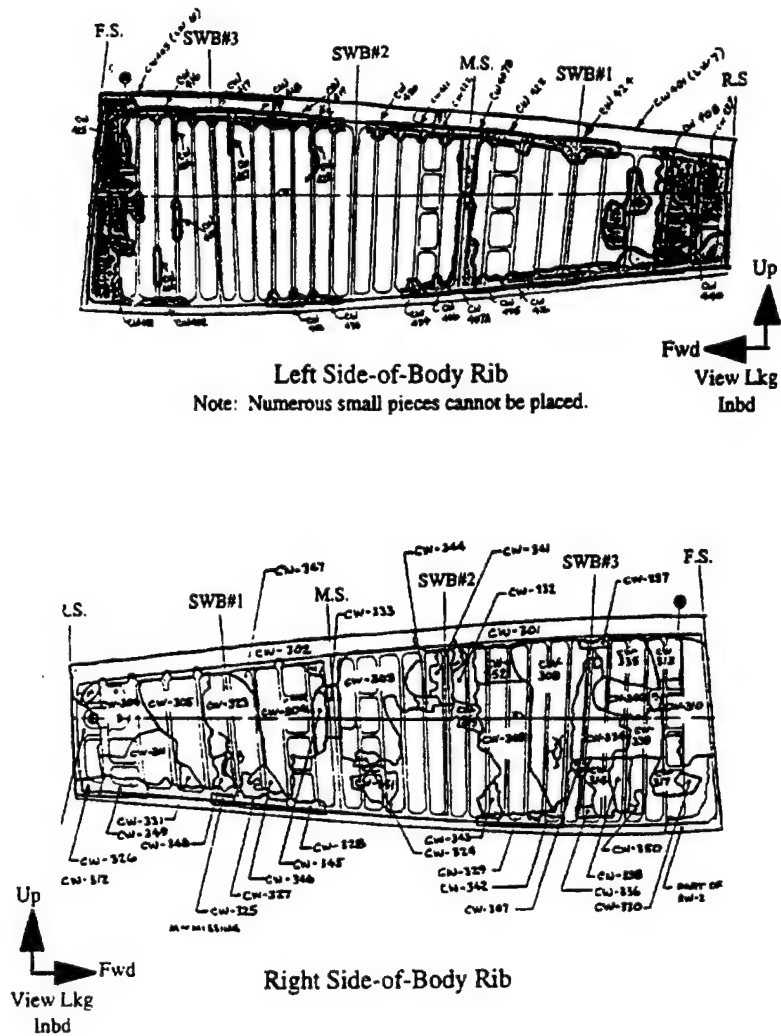
FIGURE 4. TWA Flight 800 Side-of-Body Rib Damage.

Conceivably, a missile impact in the wing-root fuel tank area could create enough damage to cause the side-of-body rib to collapse into the center wing tank. This collapse could occur without significant release of material from the wing structure, but the preponderance of evidence suggests this did not occur on TWA Flight 800. Most compelling is the fact that both wings remained with the aft fuselage section until they were well downrange. If the severe left wing damage had been caused by a missile impact, the expected result would be an early release of that wing, or at least numerous pieces of it, well uprange in the red recovery zone.
